Elm Tree Surgery & Landscaping Services Ltd.

Ref: Tree survey of trees located at rear of Sarsfield House, Francis St. Limerick.

Parkland green space at rear of Sarsfield House, and Hunt Café and Museum,

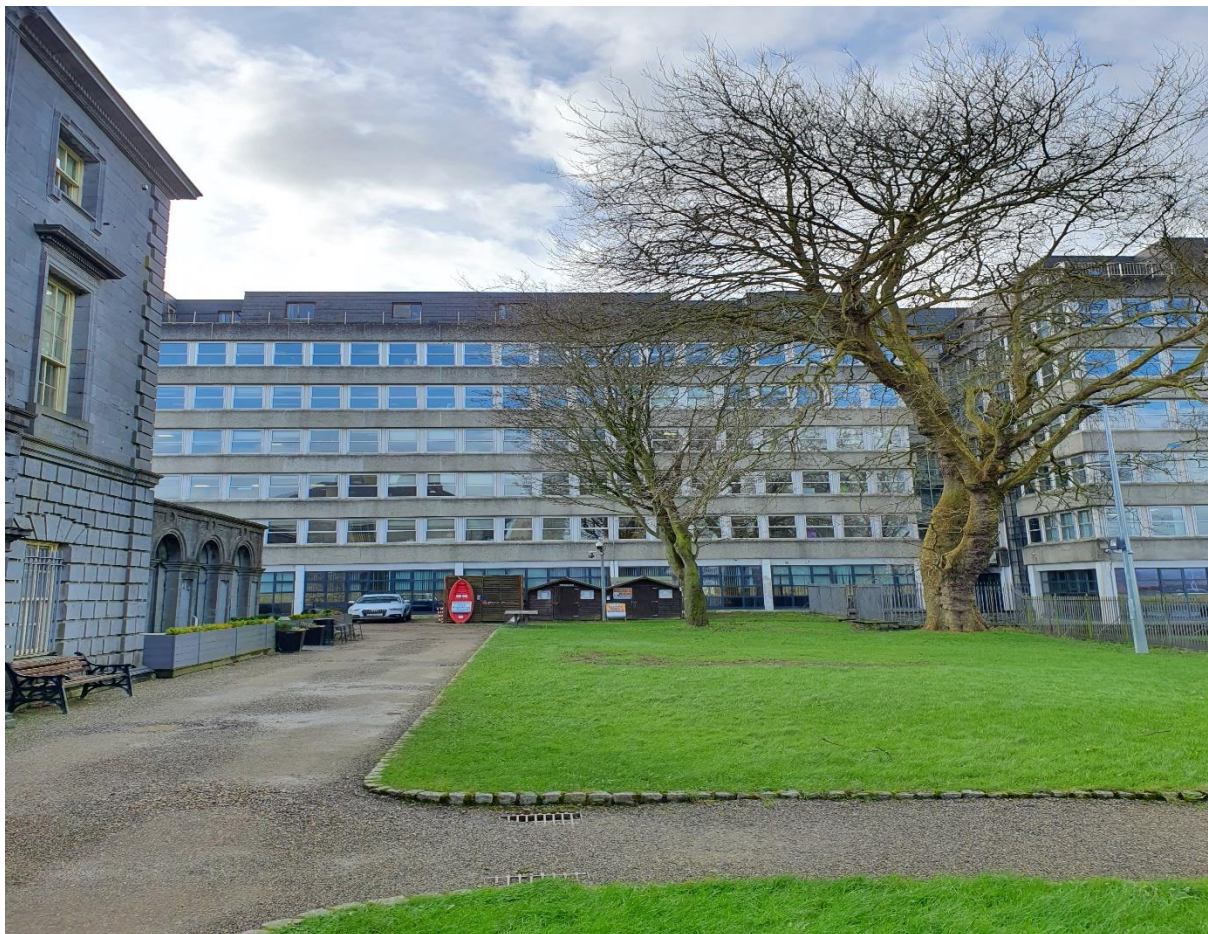
Tree located nearest the Limerick Adventures / Nev Sail cabins. Height c17mtrs. Crown width 6mtrs. DBH 0.5mtrs. Tree has a clean straight trunk / bole. It forks into a twin stem tree formation at c2.50mtrs above ground level. The crown leans away from the shadow of the large London Plane tree structure adjacent. The crown of this Acer is in poor condition with evidence of damage likely from poor topping in the past. The aerial crown contains numerous decayed sections, several hanging storm damaged and decayed branches which present as immediate hazards to park users.

Photo 1. Below. Tree 1 - Acer located on the left of frame nearest the cabins and Tree 2- London Plane located on the right of picture frame.

Tree 2 – London Plane. Photo 1 above.

A large over-mature tree located on the parkland green opposite the Hunt Café and in close proximity to the gated pedestrian access and footpath junction and path network. The tree pictured above on the right of the picture frame is approx. 26mtrs in height and the crown of this tree spreads c20mtrs in width. Approx. DBH 1.62mtrs. This large tree crown structure largely overhangs the two parklands, dividing security fence, security pole with lighting and camera infrastructure and pedestrian footpath networks. The tree forks into a twin stem tree at approx. 2.25mtrs above ground level. The lesser of the two stems contains a noticeable cavity slightly above and close to the fork union formation. The large crown contains several hanging boughs and loose debris as a result of seasonal wind blow and storm damage.

Recommendation(s): Retain tree trunk, carry out a crown removal and reduce aerial crown to healthy wood to create a pollard tree.

Recommendation:

Carry out a 45-55% crown reduction of the tree crown to alleviate aerial crown weight and risk of wind blow and storm damage. ***The cavity described above requires further aerial investigation for soundness and this may be carried out during the tree crown reduction operation. After investigation a decision may be made as to progress and remove the tree structure and stump on health and safety grounds.**

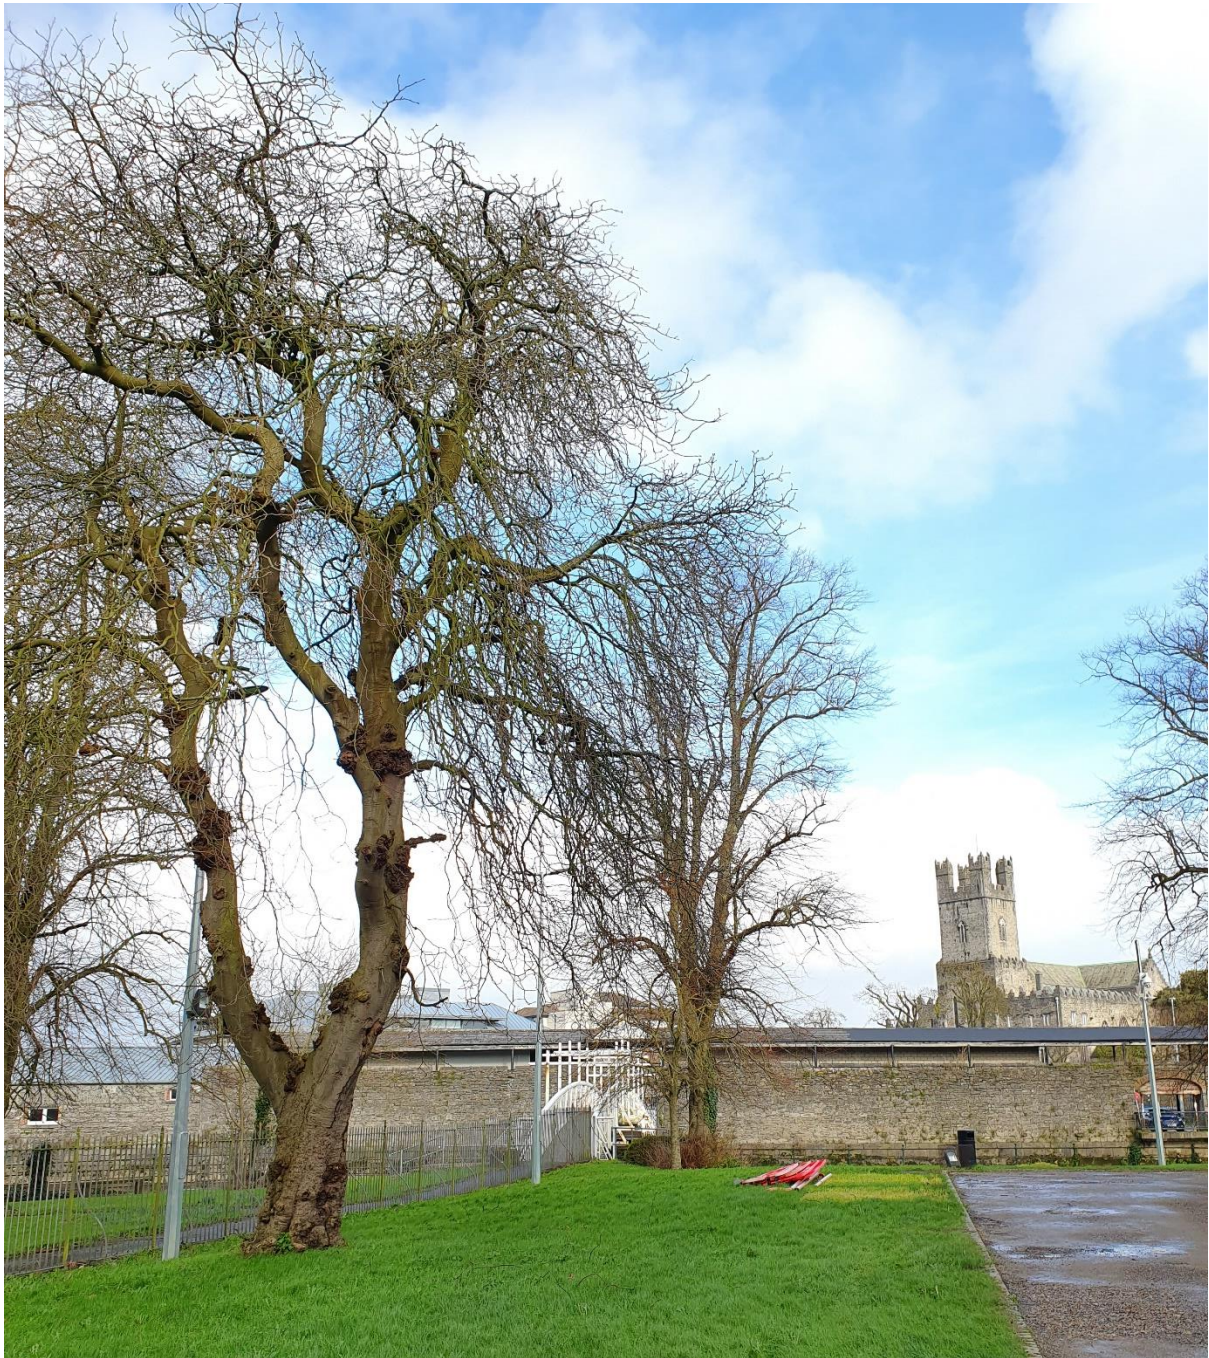
Tree 3 – Chestnut. This large tree is located close to the middle of the eastern park near the dividing metal fence and a security service light pole. The tree has a distinct fork formation at c2 mtrs. The tree has an infection and displays on the two main scaffold boughs which exhibit excessive crust formations which girdle and compromise tree soundness and tree structure stability.

Photo 2. Above – Chestnut tree.

Recommendation: Remove tree on health and safety grounds and tree care.

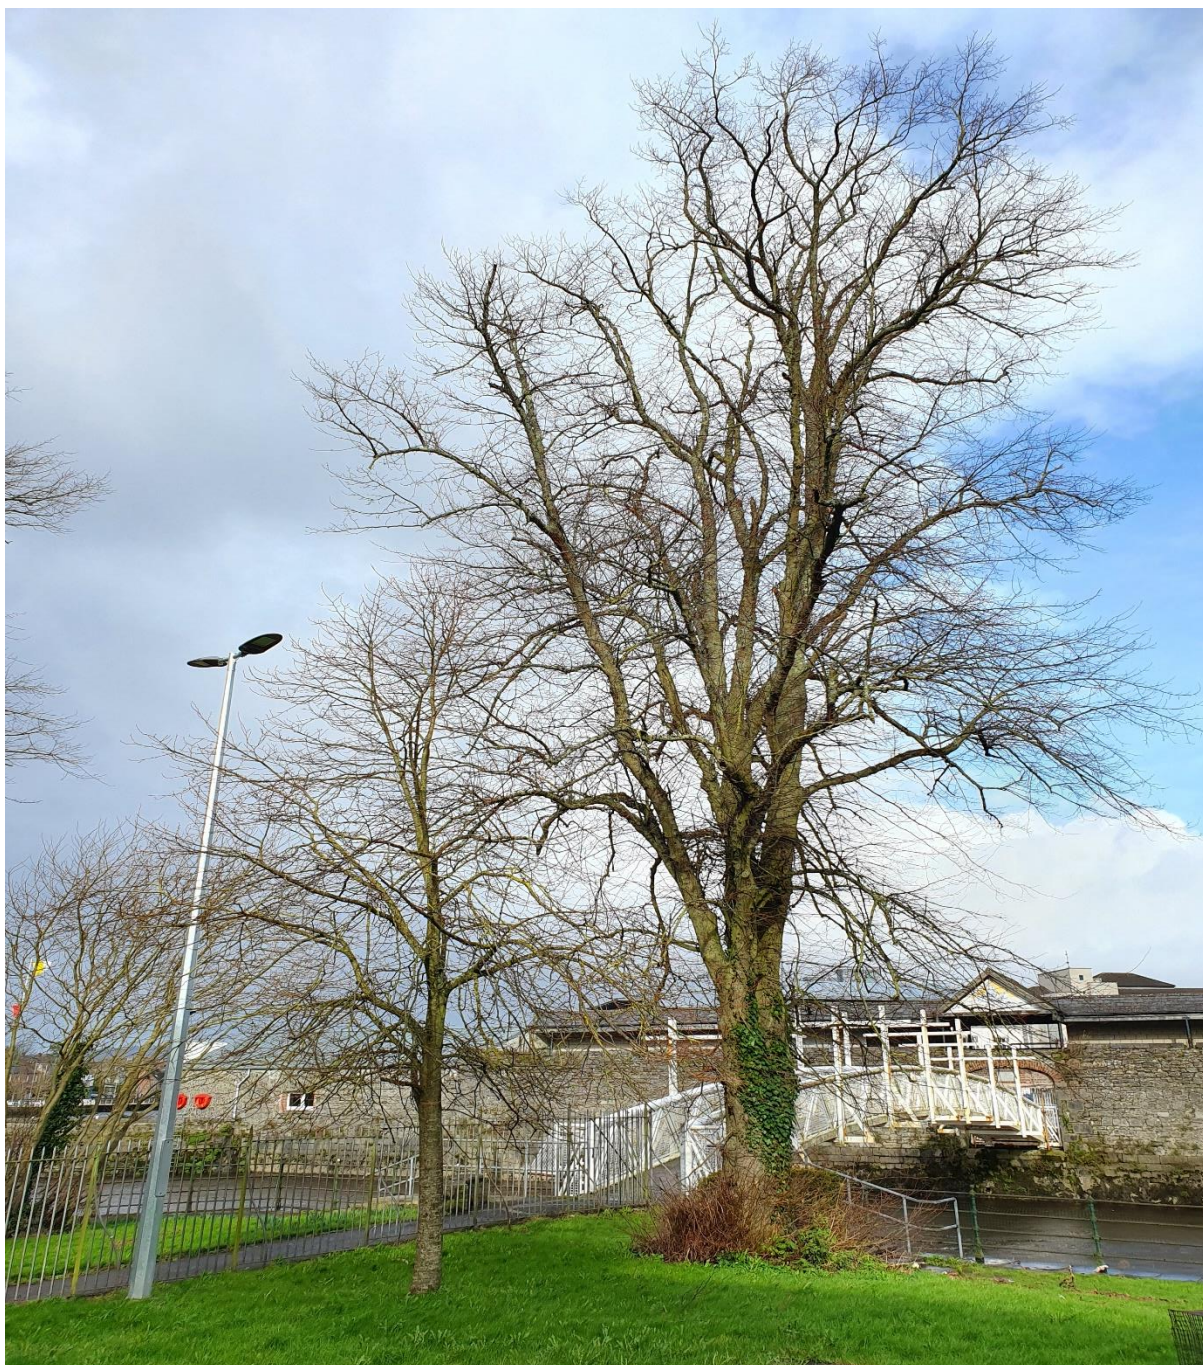
A young / semi mature tree planted in the last ten years. This tree is 6mtrs tall and in good condition and requires routine discreet formative pruning only.

Tree 5 – Lime tree. (see photo 3 below)

Located at the north western corner of the green and nearest the canal foot bridge structure. This tree is approx. 20mtrs height, with a crown spread of 12mtrs and a DBH of approx. 1.30mtrs. The tree forks at 2mtrs above ground level. The tree base and upper crown contains typical Lime sprout and thicket growth and debris. The crown contains some dieback and brittleness at upper crown extremities.

Photo 3 above. Trees 4 and 5. Near foot bridge.

Recommendation: In the interests of tree care and health and safety, carry out a crown reduction of 45% to rejuvenate crown, alleviate crown weight and reduce risk of wind blow.

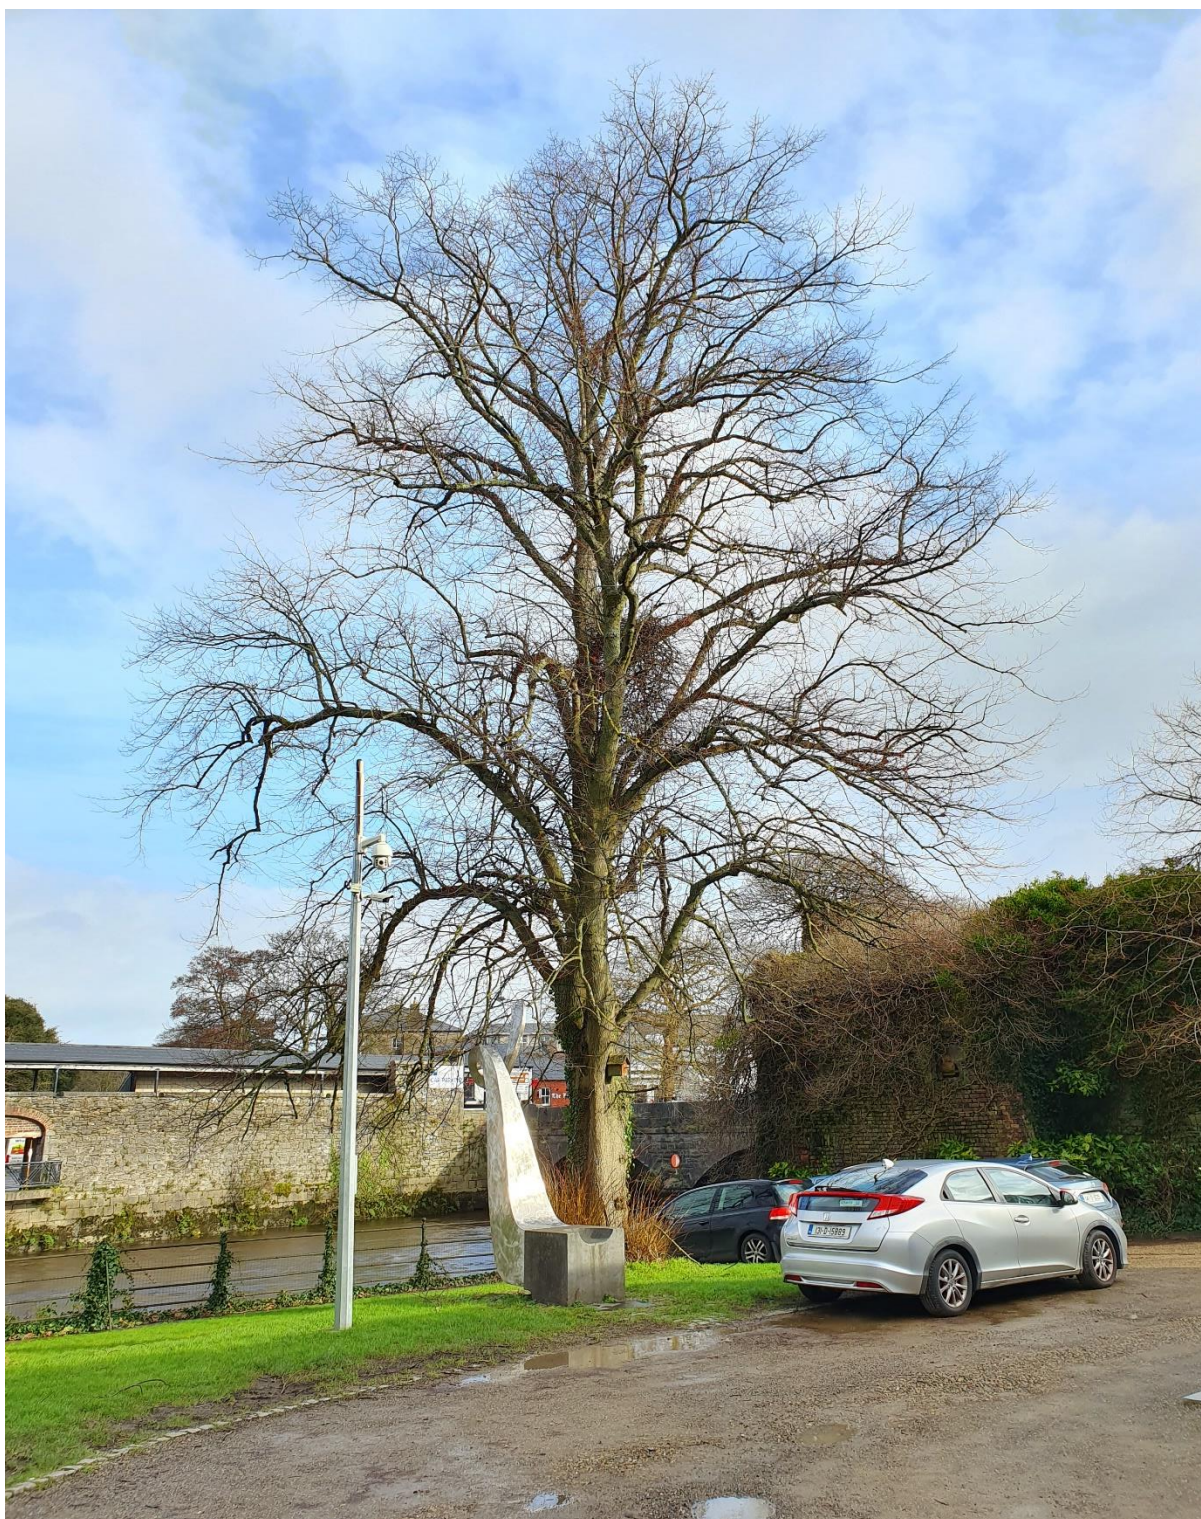
Tree 6 – Lime tree. (See photo 4 below)

This large tree is located on the narrow green along the north of the park close to the entrance driveway, the Sweeney Sculpture feature, security camera pole and the canal bank infrastructure. The tree contains an old tag 0085.

Photo 4 above. Lime tree.

Recommendations: As per tree 5. In the interests of tree care and health and safety, carry out a crown reduction of 45% to rejuvenate crown, alleviate crown weight, tree stability and reduce risk of wind blow.
