Elm Tree Surgery & Landscaping Services Ltd.

Ref: Tree survey of trees located at rear of Sarsfield House, Francis St. Limerick.

Parkland green space at rear of Sarsfield House, and Hunt Café and Museum,

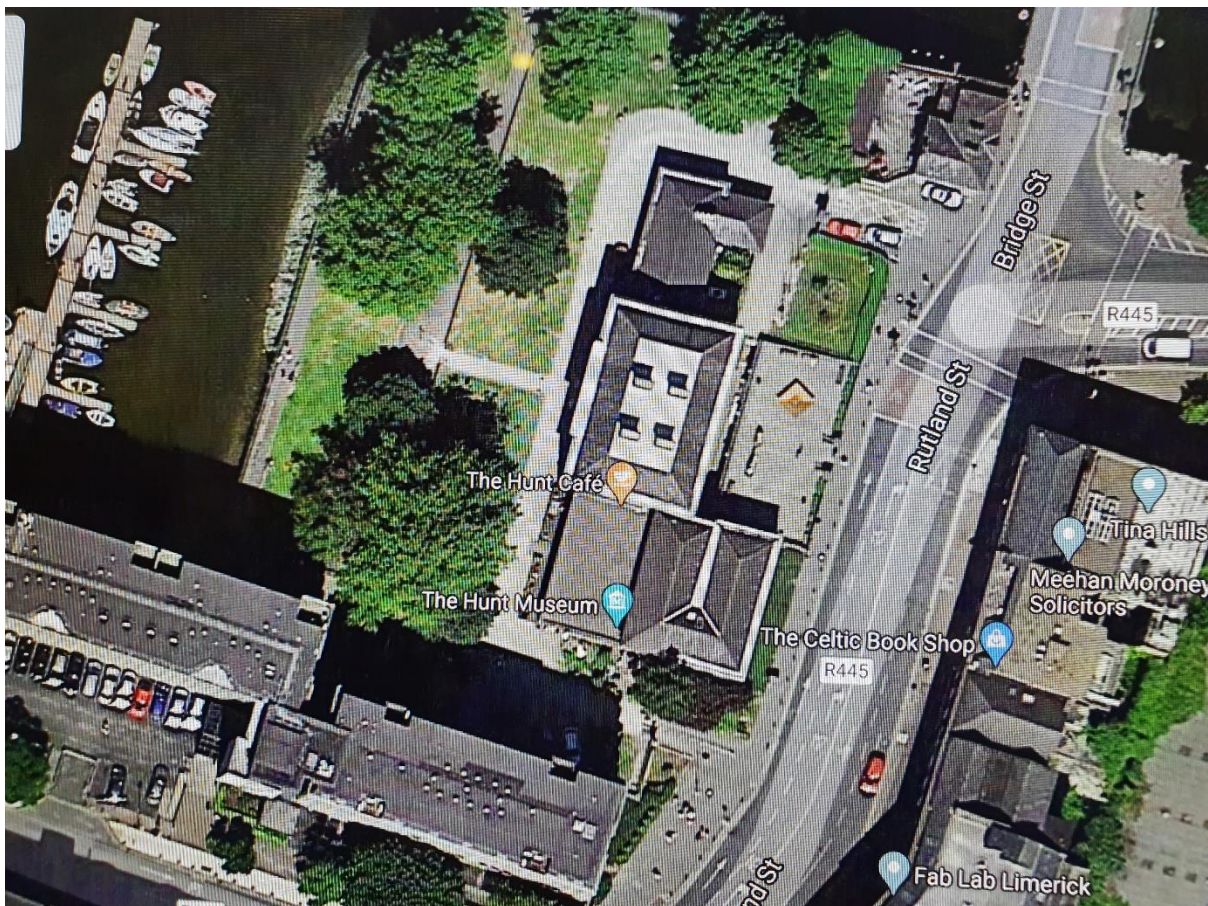
Photo 1. Aerial view of Parkland / Open green space at rear of Sarsfield House (Revenue) lower left of picture frame and The Hunt Café / Museum centre of frame.
